Citation and Notification of Penalty

Inspection Number: 311171847(12)
Inspection Date(s): 08/26/2007-02/07/2008
Issuance Date: 02/20/2008
Optional Rpt Num: Q2622-026-07
Employer ID No: 8495681-000

Accident Synopsis
Siemens Power Generation, Inc.
Q2622-026-07

INTRODUCTION

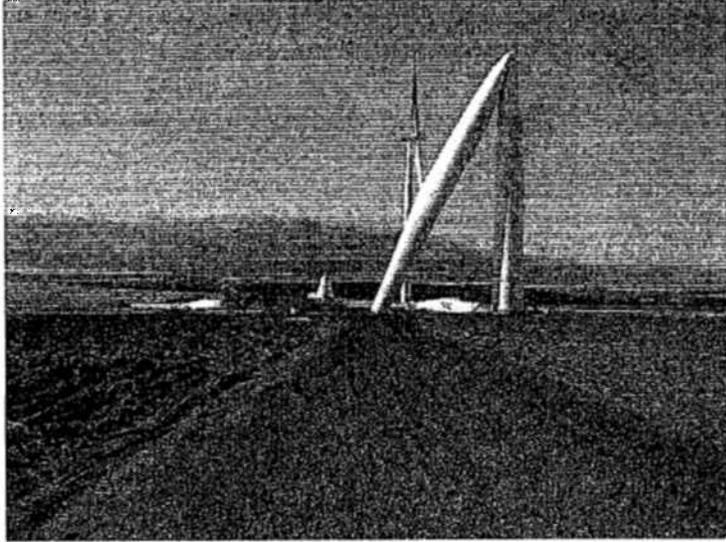
Chadd Mitchell, William Trossan and Dustin Ervin were assigned to perform maintenance work on wind turbine W1 using a 500 service checklist. Dustin had just completed loading a pickup truck with tools they had removed from the turbine to end the day. William was on his way down a fixed ladder inside the turbine tower and Chadd was in the Nacelle finishing service work when the turbine collapsed. Dustin called 911 and initiated an emergency response. Emergency responders confirmed that Chadd had received fatal injuries and found William

sitting on a ladder bracket some 20 feet up and inside of the top of the collapsed tower section. William was rescued from inside of the tower section with the assistance of Nick Martuscelli

who responded from his home in The Dalles. Nick then assisted in the removal of Chadd from the nacelle wreckage.

Based upon the data from the data recorder recovered from the wreckage of wind turbine W1 and co-worker interviews Chadd Mitchell re-entered the hub, placed all three blades in a minus two position and closed the valves that allowed automatic computer control of the blades at approximately 2:16 PM. At approximately 4:00 PM Chadd released the service brake. With blades pitched and locked in the minus 2 degree position wind energy created an over-speed condition resulting in catastrophic failure and collapse of the turbine.
