Chapter HFS 163

APPENDIX G

CONDUCTING A VISUAL INSPECTION

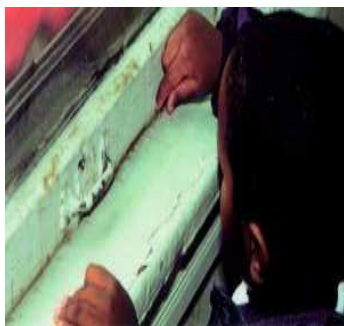
b. Mildew. A potential hazard is the formation of microbial growth on a painted surface. It is usually caused by excessive moisture. Mildew should be removed as a preventive measure to decrease the chance of paint film deterioration.

Paint affected by the mildew is deteriorated paint and must be repaired when an adhesion test determines that any layer is not securely bonded. To conduct an adhesion test, firmly press a 2" x 2" piece of masking tape to the suspect paint and rub the tape to adhere firmly. Lift up on one corner of the tape and remove the tape. If paint is evident on the tape, the paint is separating from the substrate or from underlying paint, and is not securely bonded.

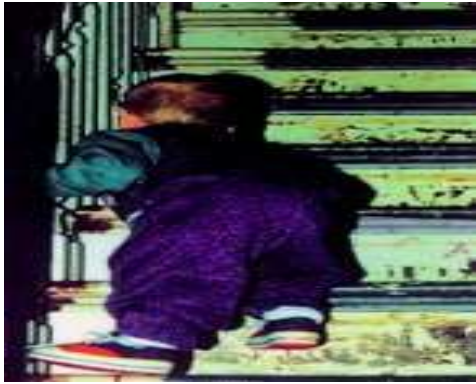
e. Painted Friction or Impact Surface. The friction and impact surfaces are evidenced by worn or chipped paint. The friction and impact of these surfaces can also result in dust-lead, which is not detected in a visual inspection.

Worn paint is often due to improperly hung doors, sticky window sashes, sticky drawers, etc. A source of dust-lead are windows that do not operate smoothly and doors that bind or otherwise contact the frame. To test for friction surfaces open and close painted doors, drawers and windows. Visually inspect doors, windows, trim, floors and stairs for evidence that the paint is worn or chipped.

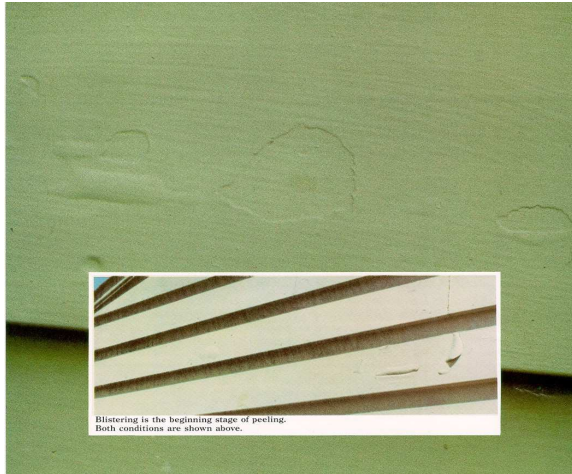
b. Blistering Paint. Blistering is the formation of bubbles in the paint film caused by either heat or moisture. To determine the cause, break open one of the bubbles; if bare substrate shows, the likely cause is moisture. However, if another layer of paint shows instead of substrate, heat probably caused the blister.

Blistering paint is deteriorated paint and must be repaired.

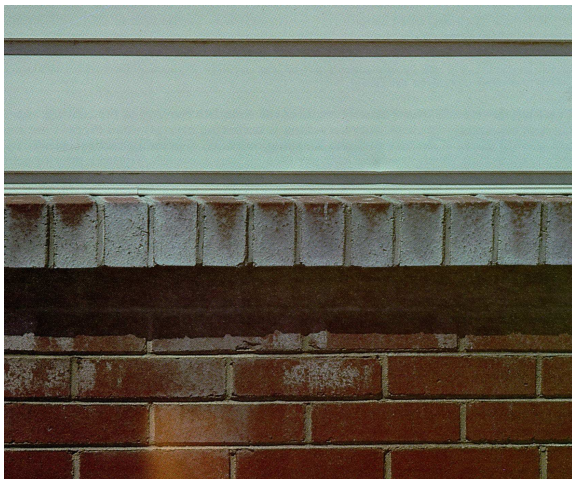
c. Chalking Paint. Chalking is the formation of a fine lead powder on the surface of a paint film. Almost all exterior oil paints are designed to eventually chalk in order to wash dirt away in the rain and provide a good surface for repainting. However, the chalking can also appear on the surfaces below the paint or on the ground. This chalking is usually caused by a failure to adequately prime or seal a porous surface, overthinning of paint, or exposure to sunlight.

Chalking paint is deteriorated paint and must be repaired.

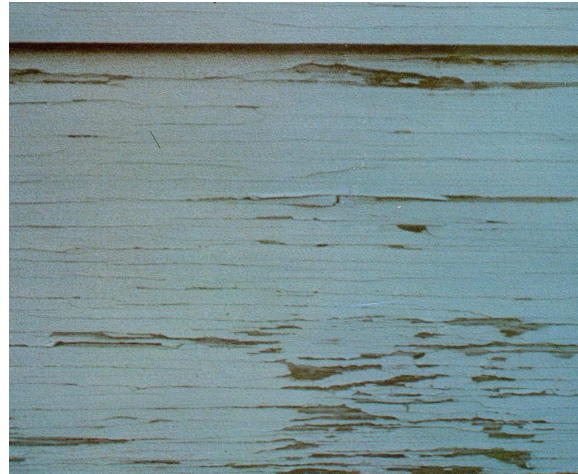
d. Checking Paint. Checking is a pattern of short, narrow breaks in the top layer of paint that is usually caused by a loss of elasticity. Plywood substrates can often cause checking.

Checking paint is deteriorated paint and must be repaired when an adhesion test determines that any layer is not securely bonded. To conduct an adhesion test, firmly press a 2" x 2" piece of masking tape to the suspect paint and rub the tape to adhere firmly. Lift up on one corner of the tape and remove the tape. If paint is evident on the tape, the paint is separating from the substrate or from underlying paint, and is not securely bonded.

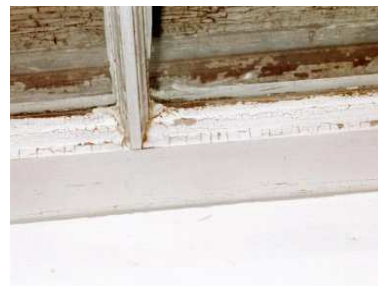
e. Chipping Paint. Paint chips are generally visible when chipping paint occurs. Chipping paint is paint that separates from the substrate due to either impact to the painted surface or poor surface preparation or paint failure.

Chipping paint is deteriorated paint and must be repaired.

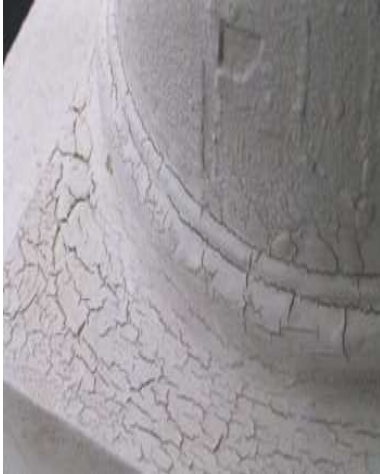
f. Cracking Paint. The cracks usually form parallel to the grain of the wood. Cracking paint is an advanced form of checking that usually occurs on surfaces with multiple layers of paint and includes breaks in the film that extend to the base substrate.

Cracking paint and cracked paint at a settlement crack is deteriorated paint and must be repaired when an adhesion test determines that any layer of paint is not securely bonded. To conduct an adhesion test, firmly press a 2" x 2" piece of masking tape to the suspect paint and rub the tape to adhere firmly. Lift up on one corner of the tape and remove the tape. If paint is evident on the tape, the paint is separating from the substrate or from underlying paint, and is not securely bonded.
