Chapter HFS 163

APPENDIX G

CONDUCTING A VISUAL INSPECTION

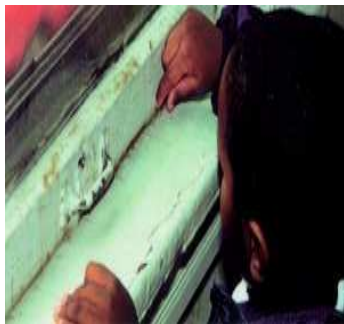
b. Mildew. A potential hazard is the formation of microbial growth on a painted surface. It is usually caused by excessive moisture. Mildew should be removed as a preventive measure to decrease the chance of paint film deterioration.

Paint affected by the mildew is deteriorated paint and must be repaired when an adhesion test determines that any layer is not securely bonded. To conduct an adhesion test, firmly press a 2" x 2" piece of masking tape to the suspect paint and rub the tape to adhere firmly. Lift up on one corner of the tape and remove the tape. If paint is evident on the tape, the paint is separating from the substrate or from underlying paint, and is not securely bonded.

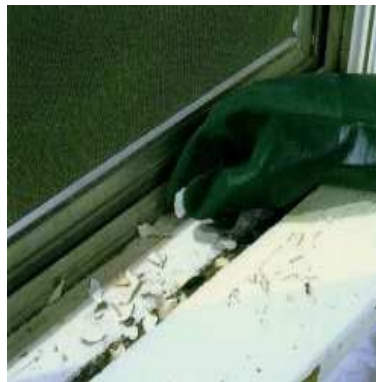
d. Paint Chips and Other Paint Debris. The presence of paint chips and debris that have not been proven to be lead-free are considered a hazard. They are evidence that paint is either deteriorated or subject to friction or impact. Visually inspect the floor, stairs, window wells/troughs and sills, and dripline for the presence of paint chips or other paint debris.

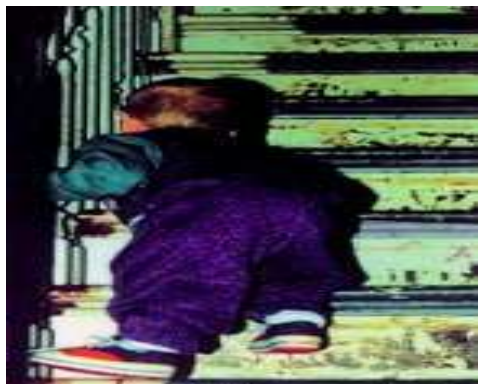
e. Painted Friction or Impact Surface. The friction and impact surfaces are evidenced by worn or chipped paint. The friction and impact of these surfaces can also result in dust-lead, which is not detected in a visual inspection.

Worn paint is often due to improperly hung doors, sticky window sashes, sticky drawers, etc. A source of dust-lead are windows that do not operate smoothly and doors that bind or otherwise contact the frame. To test for friction surfaces open and close painted doors, drawers and windows. Visually inspect doors, windows, trim, floors and stairs for evidence that the paint is worn or chipped.

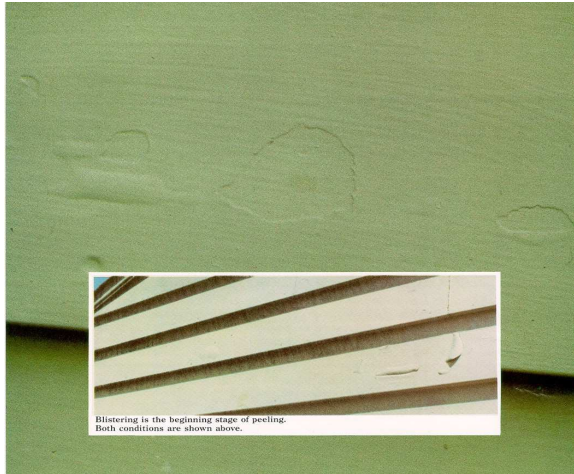
b. Blistering Paint. Blistering is the formation of bubbles in the paint film caused by either heat or moisture. To determine the cause, break open one of the bubbles; if bare substrate shows, the likely cause is moisture. However, if another layer of paint shows instead of substrate, heat probably caused the blister.

Blistering paint is deteriorated paint and must be repaired.

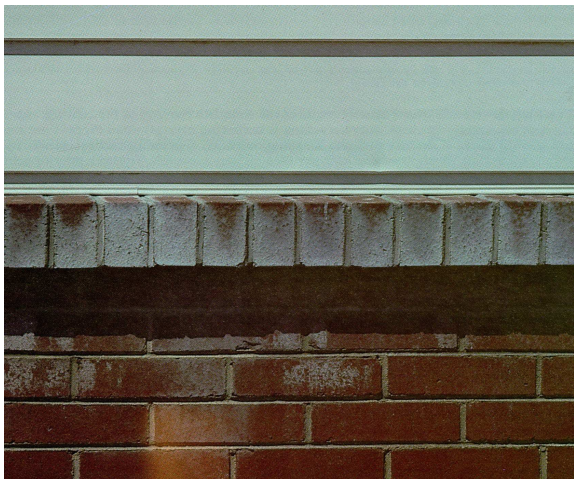
c. Chalking Paint. Chalking is the formation of a fine lead powder on the surface of a paint film. Almost all exterior oil paints are designed to eventually chalk in order to wash dirt away in the rain and provide a good surface for repainting. However, the chalking can also appear on the surfaces below the paint or on the ground. This chalking is usually caused by a failure to adequately prime or seal a porous surface, overthinning of paint, or exposure to sunlight.

Chalking paint is deteriorated paint and must be repaired.

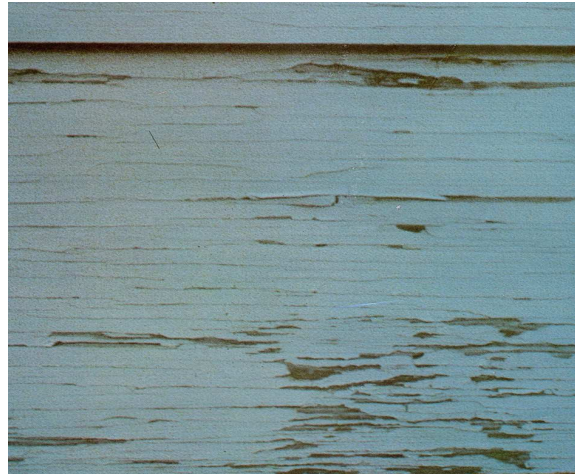
d. Checking Paint. Checking is a pattern of short, narrow breaks in the top layer of paint that is usually caused by a loss of elasticity. Plywood substrates can often cause checking.

Checking paint is deteriorated paint and must be repaired when an adhesion test determines that any layer is not securely bonded. To conduct an adhesion test, firmly press a 2" x 2" piece of masking tape to the suspect paint and rub the tape to adhere firmly. Lift up on one corner of the tape and remove the tape. If paint is evident on the tape, the paint is separating from the substrate or from underlying paint, and is not securely bonded.

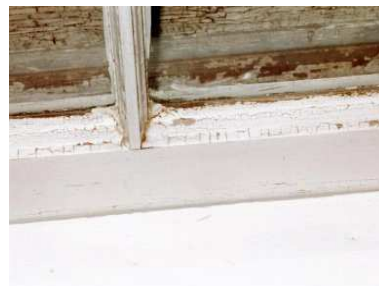
e. Chipping Paint. Paint chips are generally visible when chipping paint occurs. Chipping paint is paint that separates from the substrate due to either impact to the painted surface or poor surface preparation or paint failure.

Chipping paint is deteriorated paint and must be repaired.

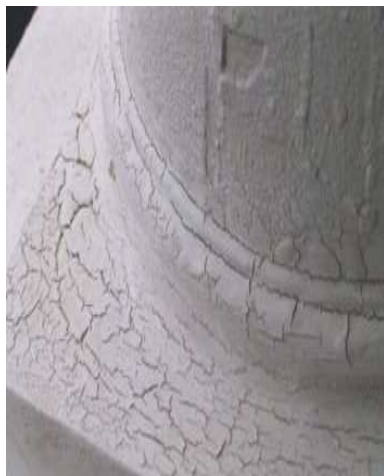
f. Cracking Paint. The cracks usually form parallel to the grain of the wood. Cracking paint is an advanced form of checking that usually occurs on surfaces with multiple layers of paint and includes breaks in the film that extend to the base substrate.

Cracking paint and cracked paint at a settlement crack is deteriorated paint and must be repaired when an adhesion test determines that any layer of paint is not securely bonded. To conduct an adhesion test, firmly press a 2" x 2" piece of masking tape to the suspect paint and rub the tape to adhere firmly. Lift up on one corner of the tape and remove the tape. If paint is evident on the tape, the paint is separating from the substrate or from underlying paint, and is not securely bonded.
