## Chapter DHS 163

### APPENDIX G

#### Conducting a Visual Inspection

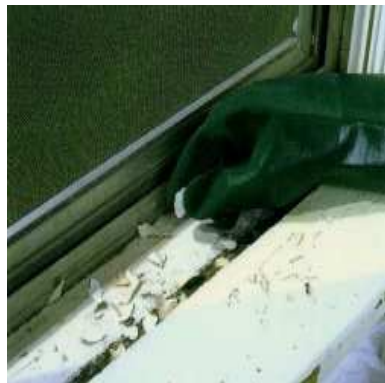
d. **Paint Chips and Other Paint Debris.** The presence of paint chips and debris that have not been proven to be lead-free are considered a hazard. They are evidence that paint is either deteriorated or subject to friction or impact. Visually inspect the floor, stairs, window wells/troughs and sills, and dripline for the presence of paint chips or other paint debris.

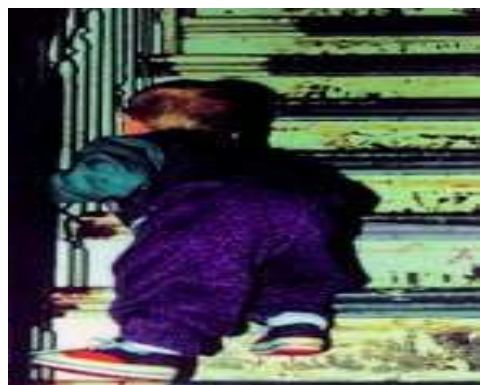
e. **Painted Friction or Impact Surface.** The friction and impact surfaces are evidenced by worn or chipped paint. The friction and impact of these surfaces can also result in dust-lead, which is not detected in a visual inspection.

Worn paint is often due to improperly hung doors, sticky window sashes, sticky drawers, etc. A source of dust-lead are windows that do not operate smoothly and doors that bind or otherwise contact the frame. To test for friction surfaces open and close painted doors, drawers and windows. Visually inspect doors, windows, trim, floors and stairs for evidence that the paint is worn or chipped.

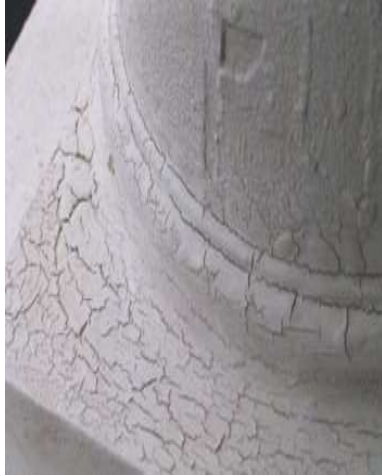
f. Cracking Paint. The cracks usually form parallel to the grain of the wood. Cracking paint is an advanced form of checking that usually occurs on surfaces with multiple layers of paint and includes breaks in the film that extend to the base substrate.

Cracking paint and cracked paint at a settlement crack is deteriorated paint and must be repaired when an adhesion test determines that any layer of paint is not securely bonded. To conduct an adhesion test, firmly press a 2" x 2" piece of masking tape to the suspect paint and rub the tape to adhere firmly. Lift up on one corner of the tape and remove the tape. If paint is evident on the tape, the paint is separating from the substrate or from underlying paint, and is not securely bonded.
